11.05 – Magma FRS DAM
Safety Inspection Conducted on 02/17/2010
Photographer: Chuck Merritt

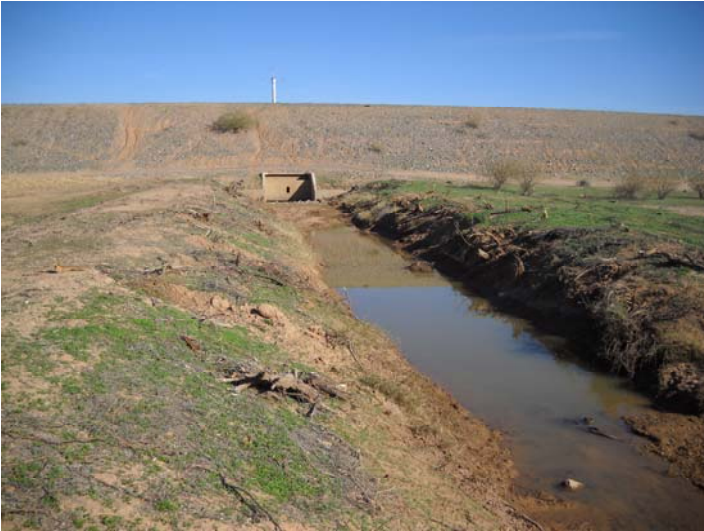
PHOTO NUMBER: 1
PHOTO DIRECTION: North
DESCRIPTION: Outlet channel. ALERT gage can be seen on crest of dam. Recently cleared of brush.

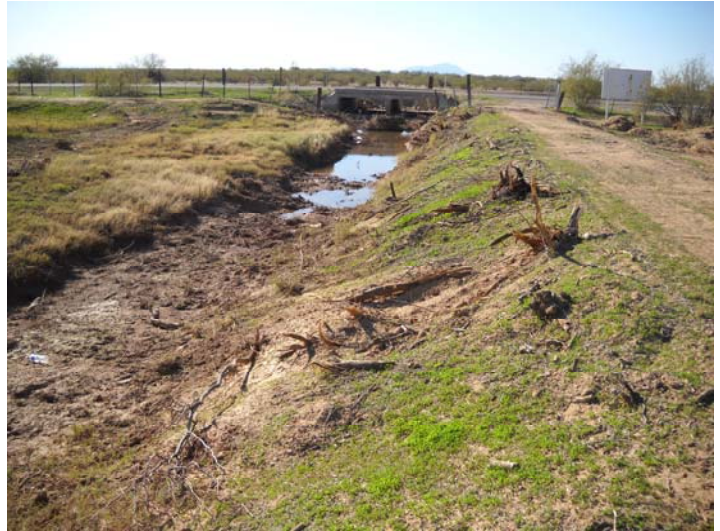
PHOTO NUMBER: 2
PHOTO DIRECTION: South
DESCRIPTION: Outlet channel with access gate at right. Bridge is on Arizona Farms Road.

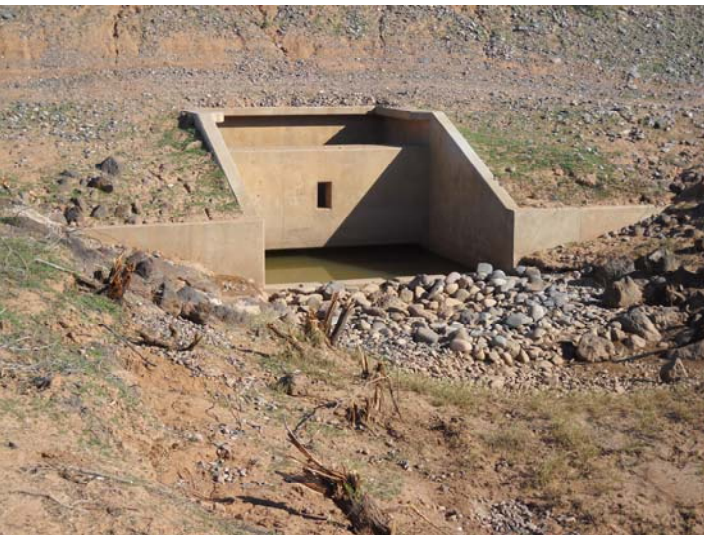
PHOTO NUMBER: 3
PHOTO DIRECTION: North
DESCRIPTION: Outlet structure and baffle basin.

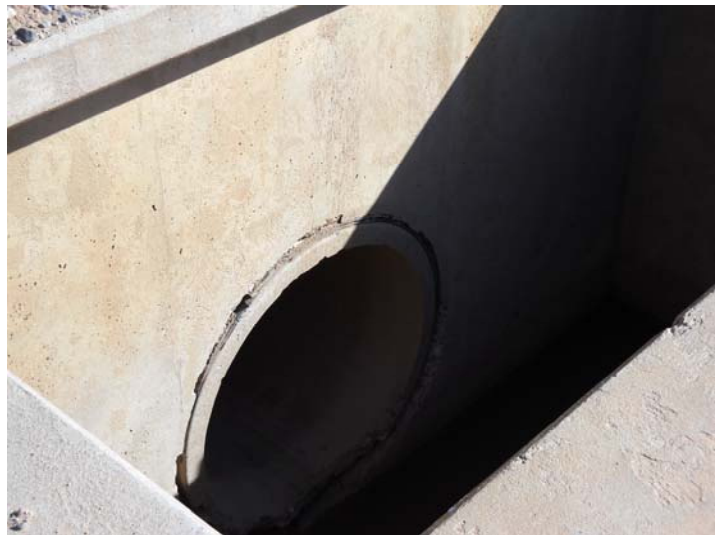
PHOTO NUMBER: 4
PHOTO DIRECTION: Northeast
DESCRIPTION: RCP at outlet structure. Open and clear as shown in photo 16.

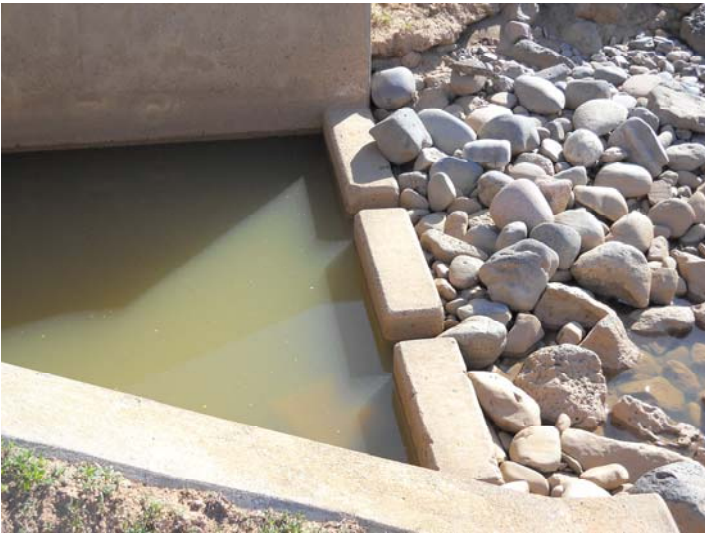
PHOTO NUMBER: 5
PHOTO DIRECTION: East
DESCRIPTION: Stilling basin and wing walls. Appears free of cracks and spalls.

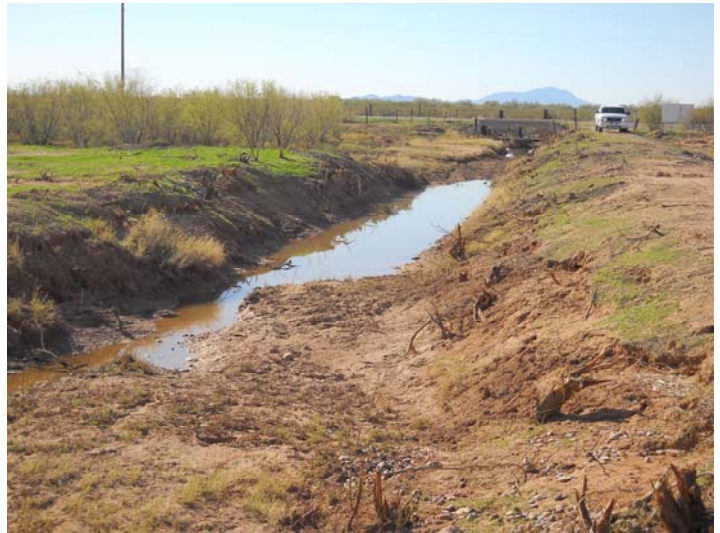
PHOTO NUMBER: 6
PHOTO DIRECTION: South
DESCRIPTION: Outlet channel recently cleared of obstructive woody vegetation.

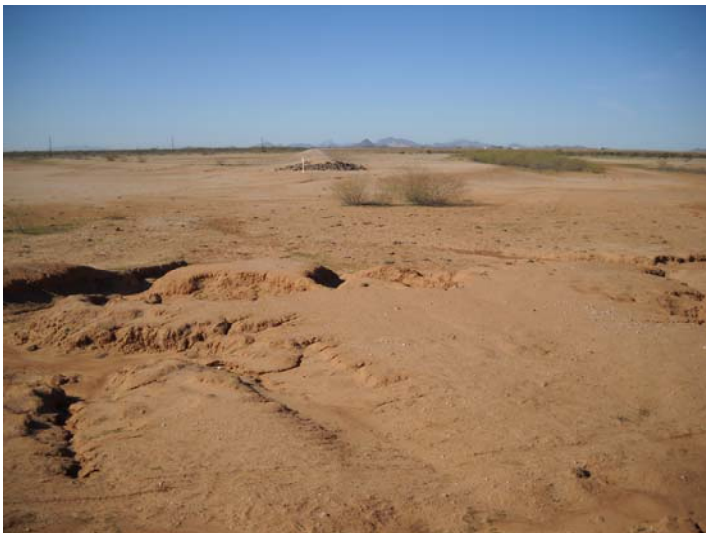
PHOTO NUMBER: 7
PHOTO DIRECTION: West
DESCRIPTION: Looking across emergency spillway control section at left end of dam (riprap). In foreground is training dike.

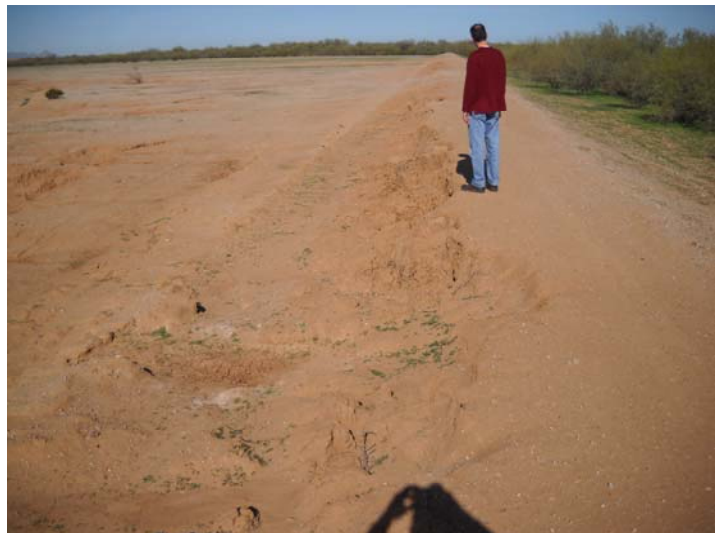
PHOTO NUMBER: 8
PHOTO DIRECTION: North
DESCRIPTION: Emergency Spillway training dike shows signs of heavy local rain/surface flow as evidenced by erosion.

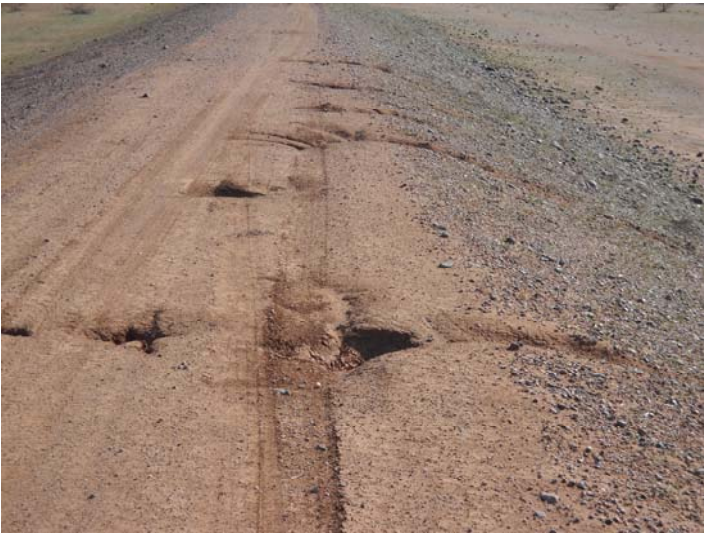
PHOTO NUMBER: 9
PHOTO DIRECTION: East
DESCRIPTION: Crest of dam with transverse cracking and erosion.

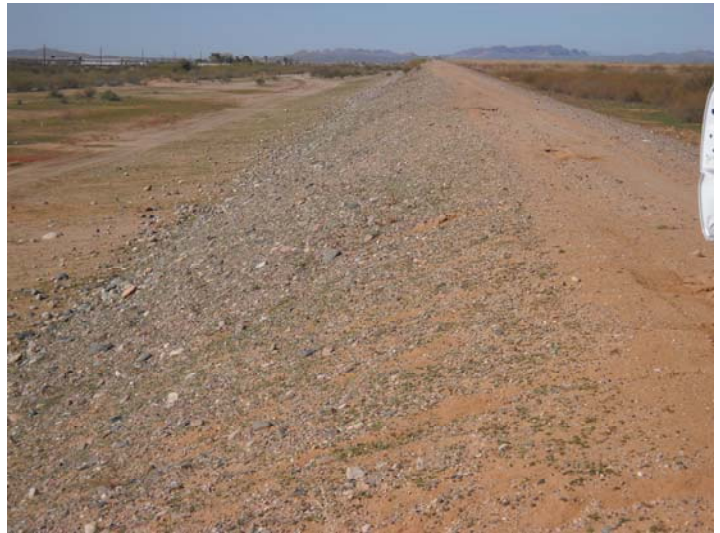
PHOTO NUMBER: 10
PHOTO DIRECTION: West
DESCRIPTION: Downstream slope and crest.

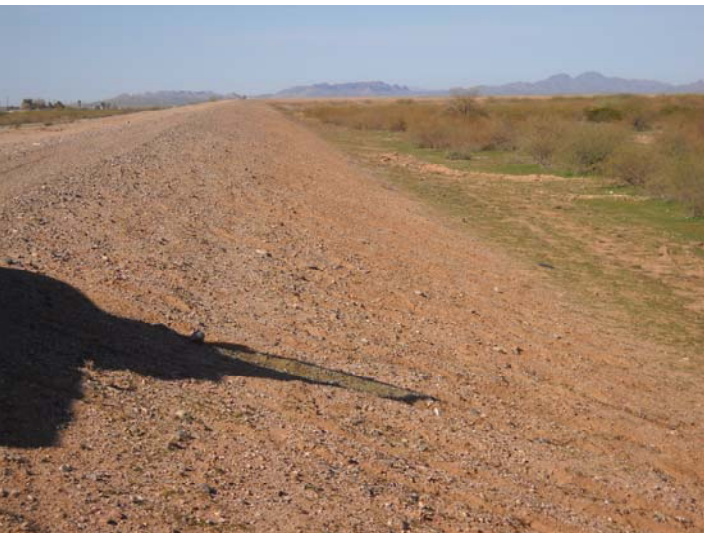
PHOTO NUMBER: 11
PHOTO DIRECTION: West
DESCRIPTION: Upstream slope and reservoir area.

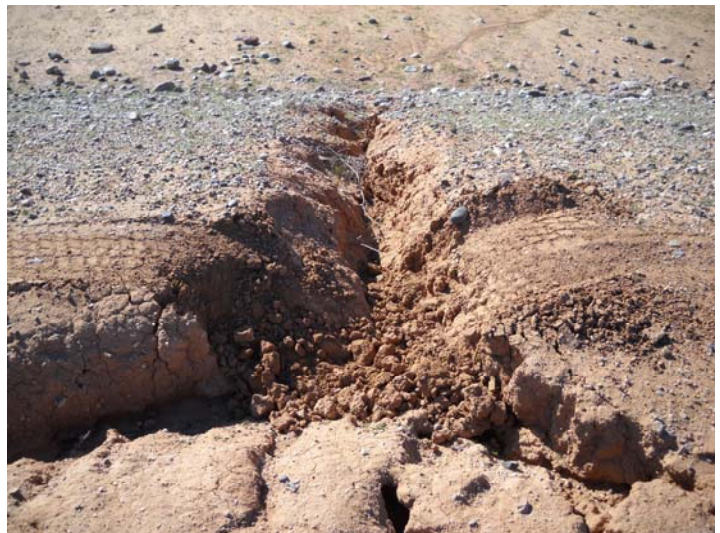
PHOTO NUMBER: 12
PHOTO DIRECTION: South
DESCRIPTION: Transverse crack in crest.

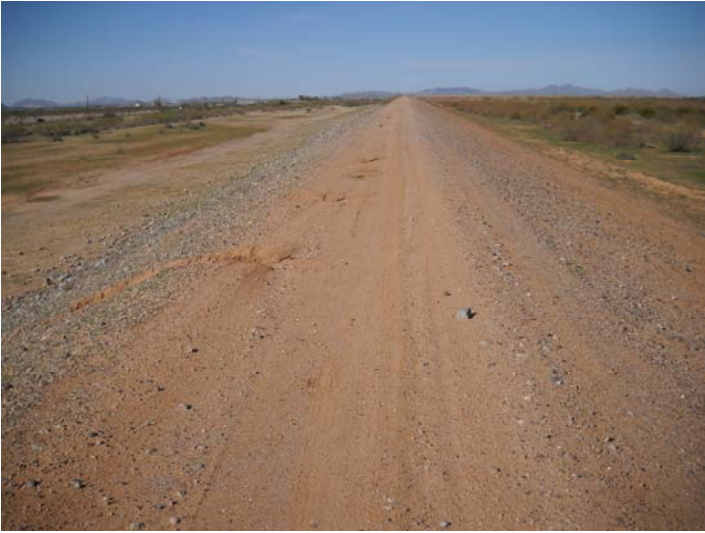
PHOTO NUMBER: 13
PHOTO DIRECTION: West
DESCRIPTION: Crest of dam with sinkholes at cracks

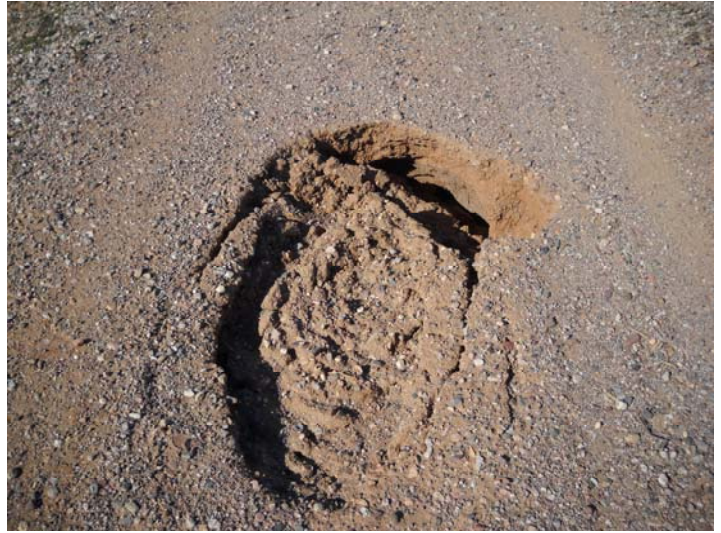
PHOTO NUMBER: 14
PHOTO DIRECTION: NA
DESCRIPTION: A developing sinkhole on crest.

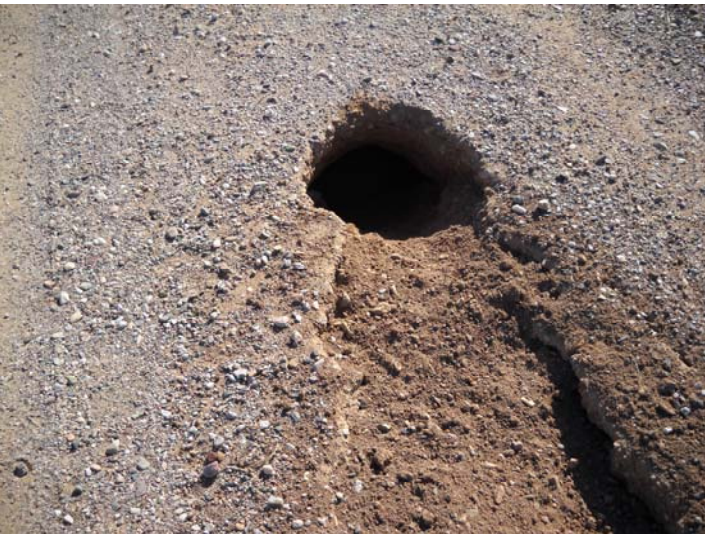
PHOTO NUMBER: 15
PHOTO DIRECTION: NA
DESCRIPTION: Rodent burrow within crack.

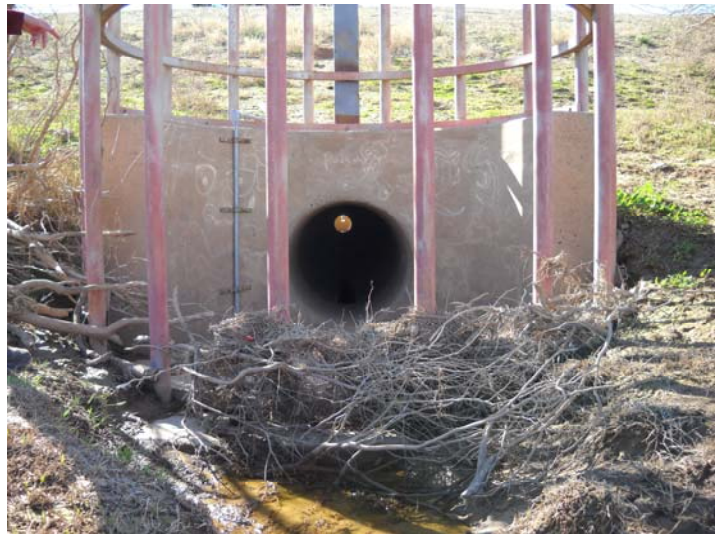
PHOTO NUMBER: 16
PHOTO DIRECTION: South
DESCRIPTION: Inlet structure, conduit and trash rack.

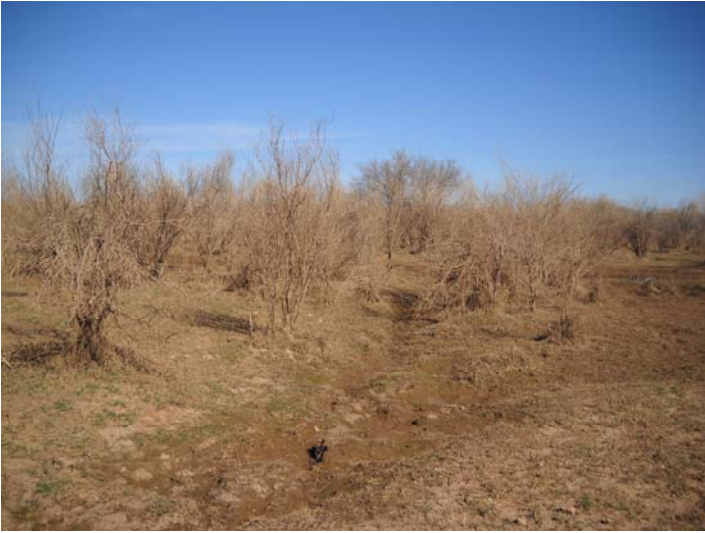
PHOTO NUMBER: 17
PHOTO DIRECTION: North
DESCRIPTION: Inlet 'channel' as seen from inlet within reservoir.

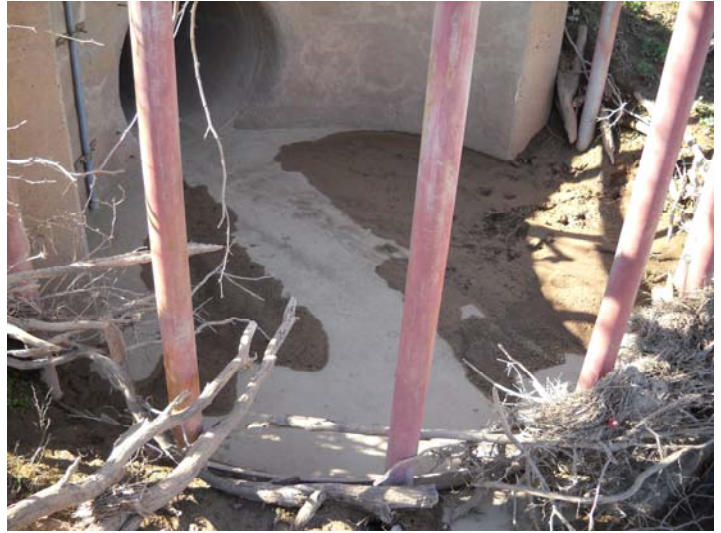
PHOTO NUMBER: 18
PHOTO DIRECTION: Southwest
DESCRIPTION: Inlet structure and trashrack.

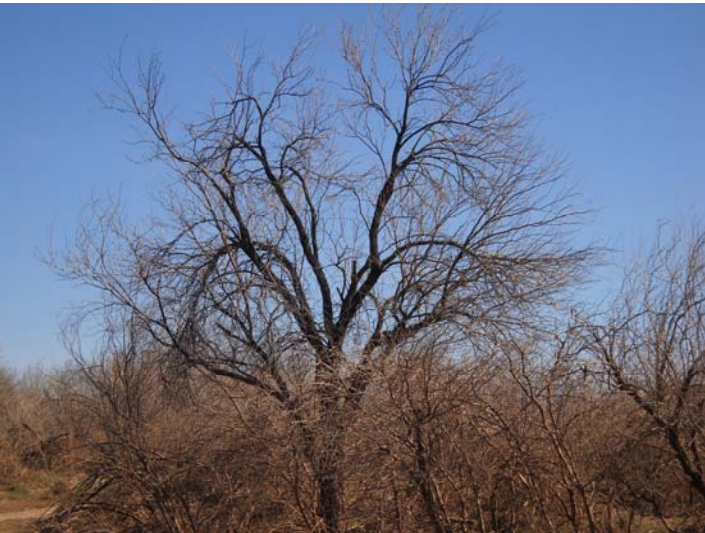
PHOTO NUMBER: 19
PHOTO DIRECTION: North
DESCRIPTION: Potential debris with reservoir.

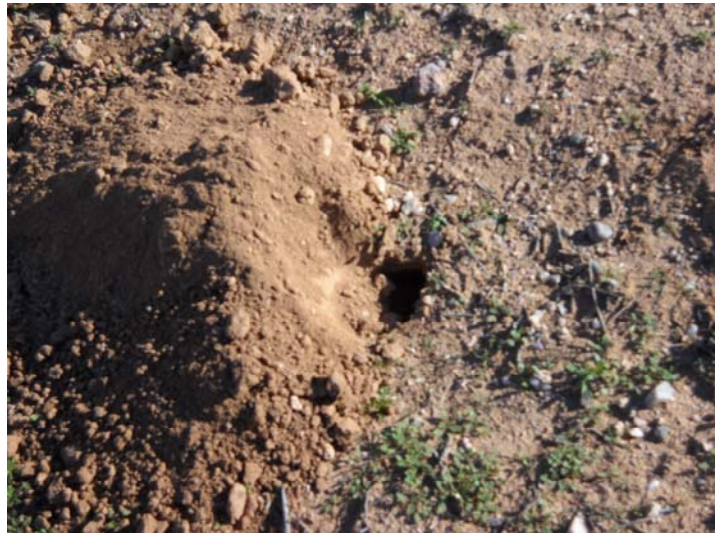
PHOTO NUMBER: 20
PHOTO DIRECTION: NA
DESCRIPTION: Rodent burrow on upstream slope (typ.). Near inlet structure.

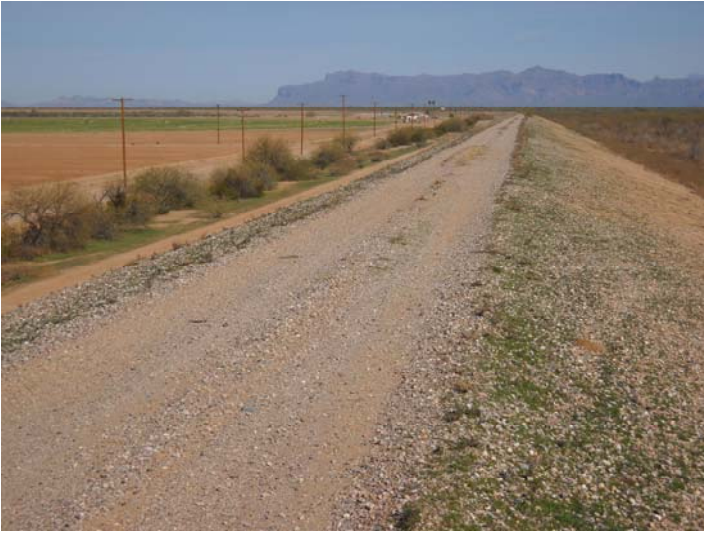
PHOTO NUMBER: 21
PHOTO DIRECTION: North
DESCRIPTION: Crest of dam and upstream slope (west leg).

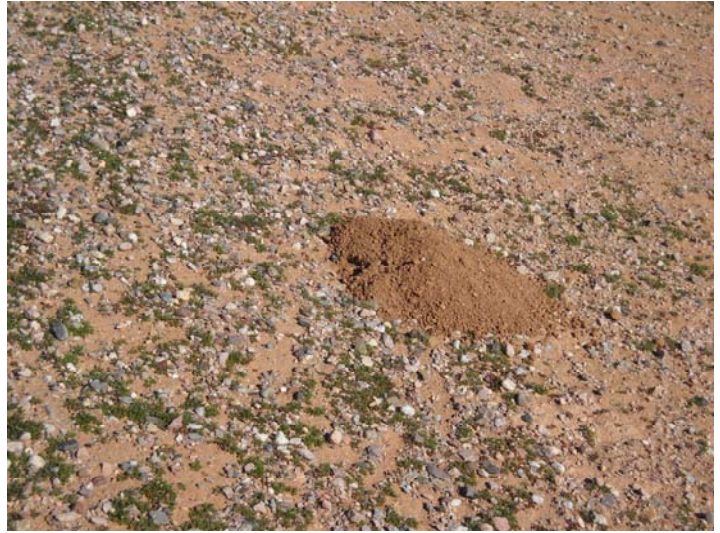
PHOTO NUMBER: 22
PHOTO DIRECTION: NA
DESCRIPTION: Rodent burrow on upstream slope.

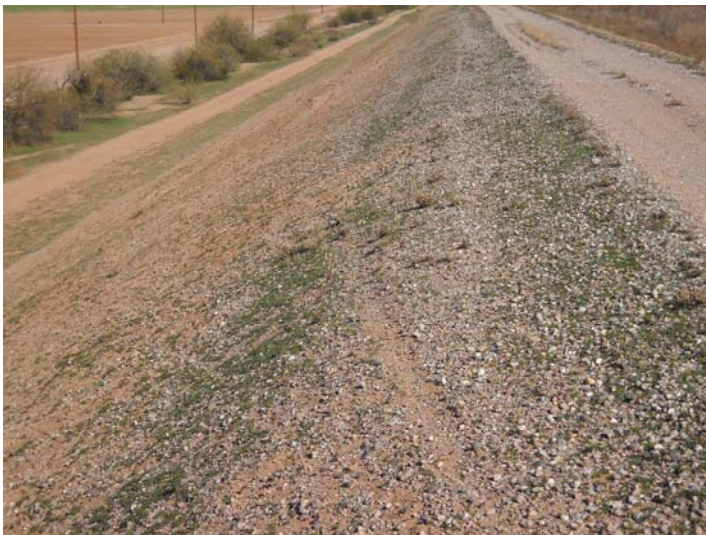
PHOTO NUMBER: 23
PHOTO DIRECTION: North
DESCRIPTION: Downstream slope west leg of dam.

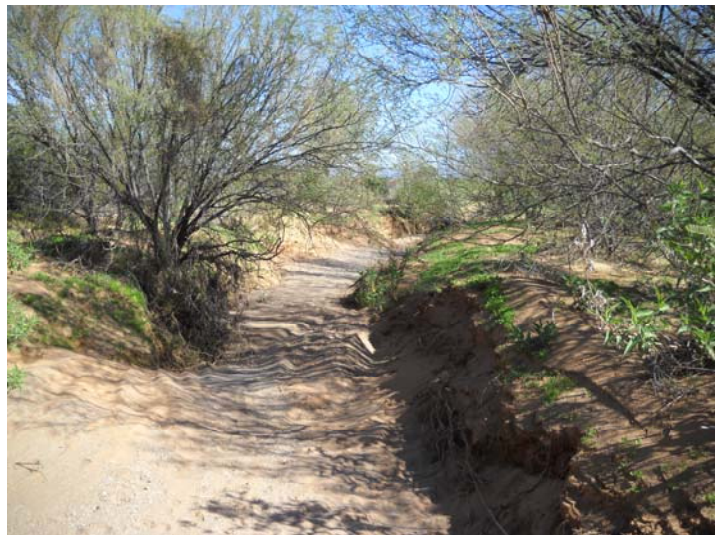
PHOTO NUMBER: 24
PHOTO DIRECTION: Northeast
DESCRIPTION: An inlet channel at the northwest corner of the reservoir near the RR tracks.
